Big Ravine Preserve Erosion Control and  
Restoration Plan  
Bayfield, WI

December 2, 2020

## Big Ravine Preserve- Erosion Control Management and Restoration

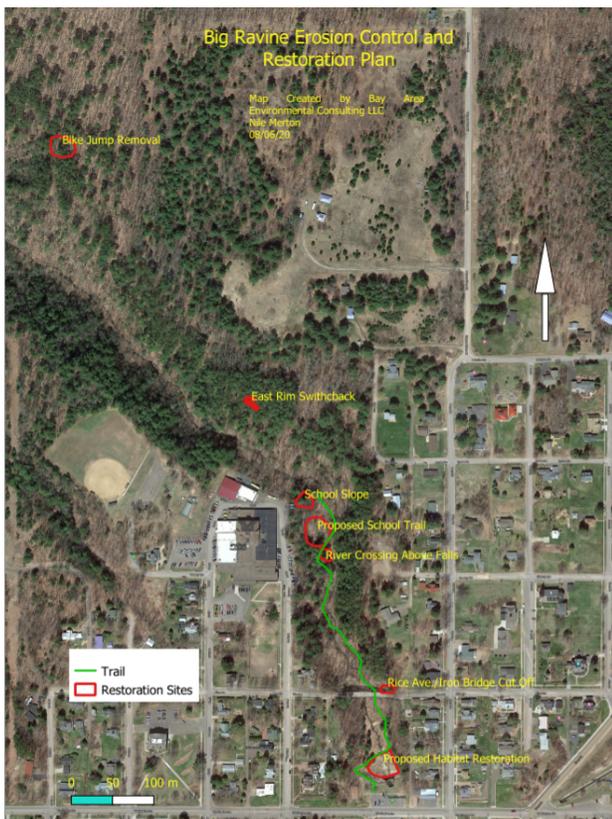
Overview map of the seven restoration sites covered in this plan.

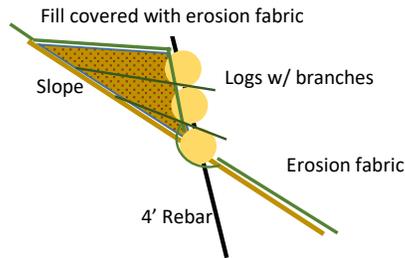
Check steps are small platforms created by using anchors made of wood or metal and logs which is then back filled with soil. These intercept water and slow the rate of runoff, thereby reducing erosion. The check steps also offer a more stable environment to plant vegetation, which once takes root, will further help stabilize the slope. Erosion control fabric and fine woody debris will be layered into each check step to add coarse texture.

Number of Steps: 4  
Height: 18"  
Width(s): 1@12', 3@6'

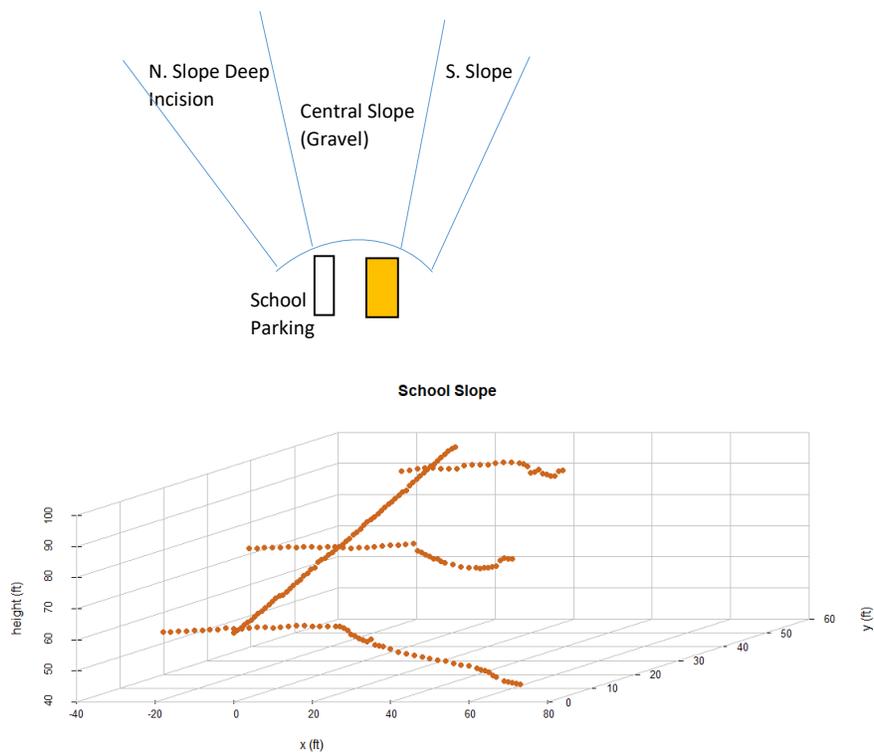
3D illustration of transects taken of eroding slope behind the school parking area. Note the scour chute on the north slope.

This site will require the most time, work and money to remediate. On this slope there are three sections of concern: 1) The center slope, where several layers of gravel have been pushed by past snow dumping, 2) the northern slope and 3) the southern slope. Each of these three sections will require attention with varying erosion control methods. It appears that the northern slope was an old landslide event that started to stabilize but is once again starting to erode near the top. The southern slope appears to be a historic water way with healthy vegetation but could use some light remediation in areas.

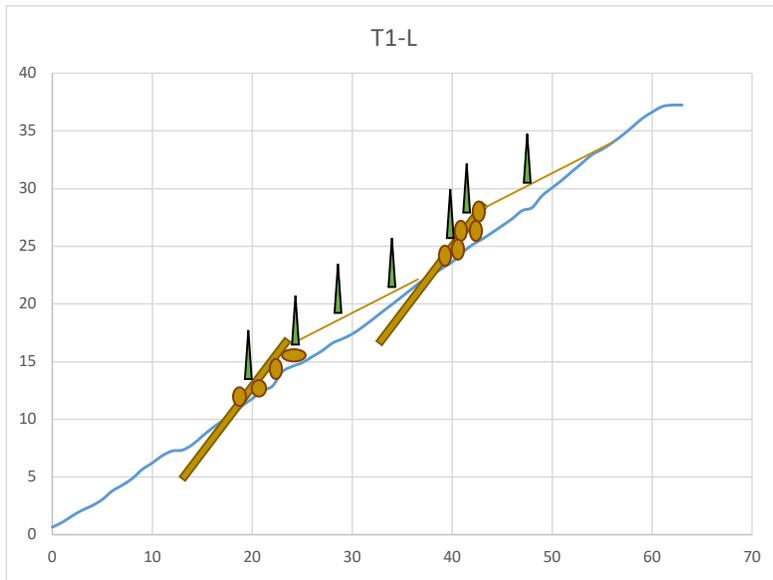
Graphic showing suggested, "Log Jams," on central slope.

BAEC proposes two large log jams be installed, back filled, revegetated, and covered with erosion control fabric. These log jams will act in a similar way to the check steps at Site 1 in retaining soil but will be a shallower angle and more intensively anchored and built into the hill side. Large but varying sized logs with branches left attached to knit the logs together and to add, "texture," for other sticks and soil to get tangled in. See the diagrams and schematics on the following page.

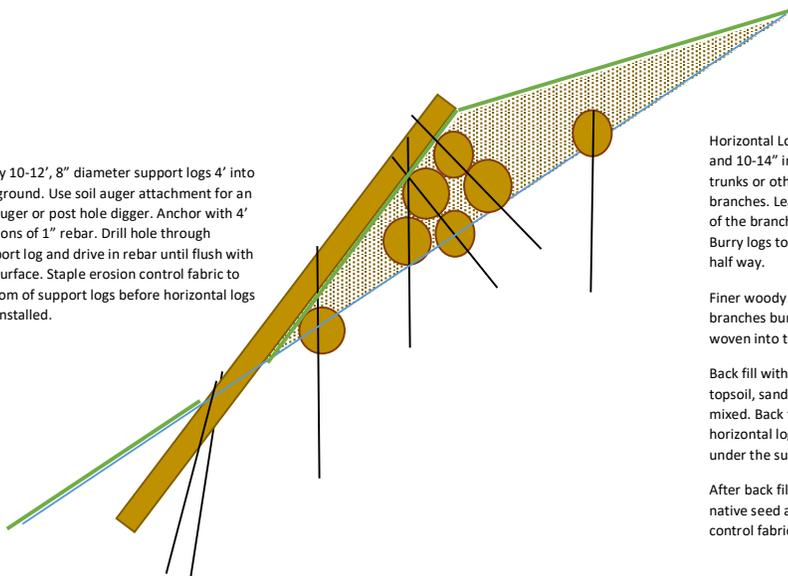
### Log Jam Schematics.

Bury 10-12', 8" diameter support logs 4' into the ground. Use soil auger attachment for an ice auger or post hole digger. Anchor with 4' sections of 1" rebar. Drill hole through support log and drive in rebar until flush with log surface. Staple erosion control fabric to bottom of support logs before horizontal logs are installed.

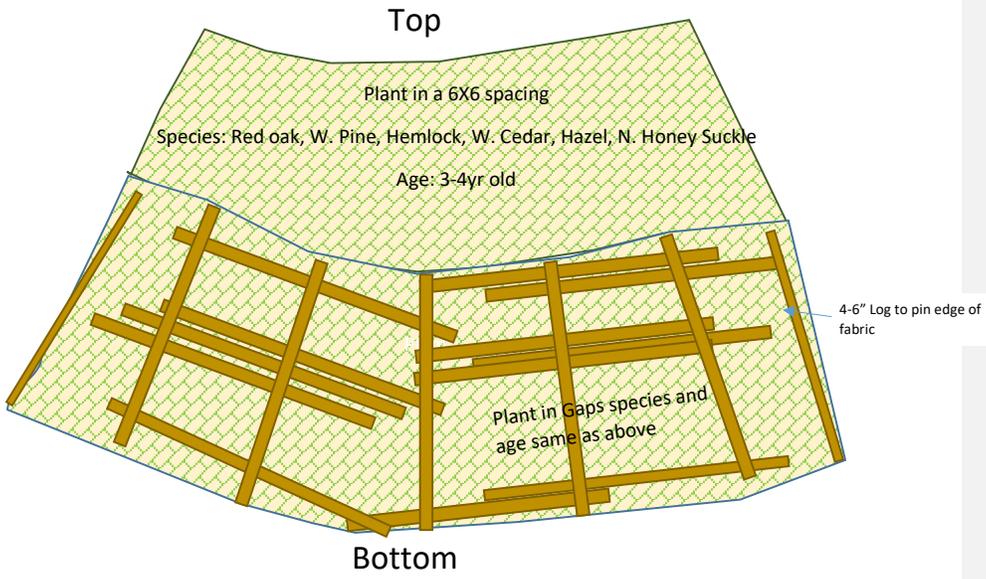
Horizontal Logs: 10-12' long and 10-14" in diameter. Pine trunks or other species with branches. Leave 1-2' lengths of the branches on the logs. Bury logs touching the slope half way.

Finer woody debris: ½- 1 ½" branches bundled and inter woven into the larger logs.

Back fill with a soil that is topsoil, sand, and gravel mixed. Back fill in stages as horizontal logs are added under the support logs

After back filling 12-15' lay native seed and erosion control fabric.

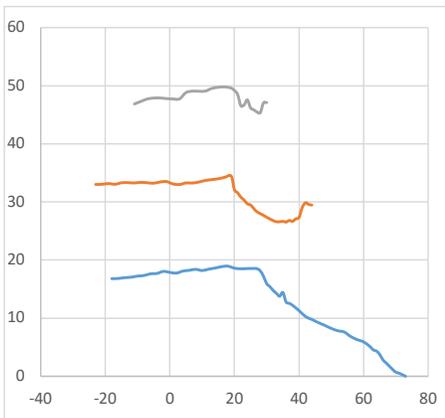
Cross Section Transects of the eroding slope. Note the old scour chute on the right hand side of each transect.

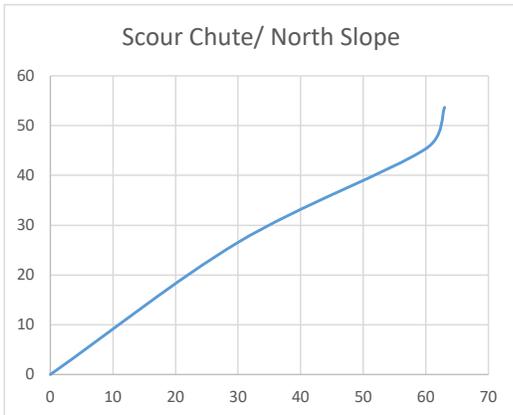
Length transect of the North slope/scour chute. Note at the top of the graph there is a steep drop. This is newer erosion that has happened in the las couple years.

The northern slope appears to be an old erosion channel that is once again eroding near the top of the slope. This area will need to be heavily terraced to fully remediate past and future erosion. BAEC recommends three terrace steps in this area evenly spaced up the slope. Each of these steps will be varying heights based on the depth of the erosion channel. To build these steps a similar strategy to the log jam design will be built. These however will need to be more vertical due to the grade of the slope and in order to hold enough soil to reduce the grade enough for future stability.

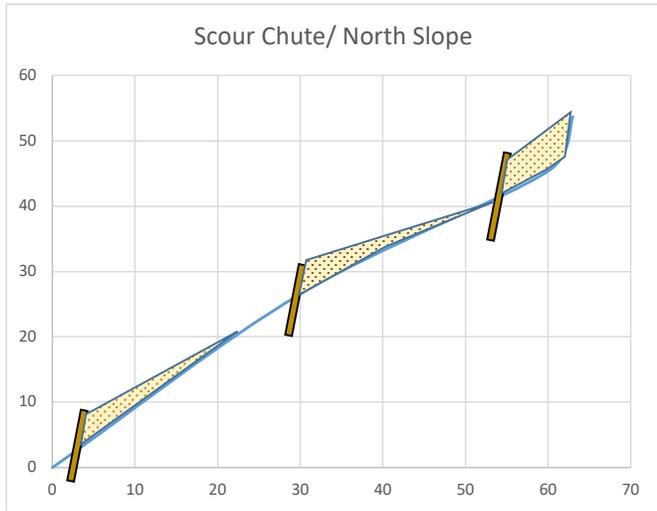
Graphic depicting log wall/steps in the scour chute of the north slope.

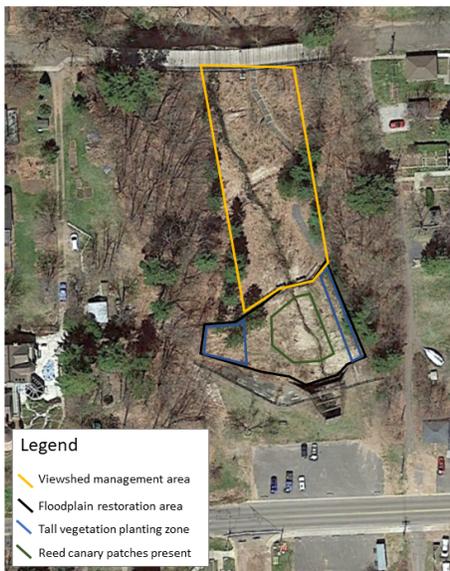
Area between Iron Bridge and erosion control structure where vegetation will be managed to enhance the view of the Iron Bridge, to control invasive species, and encourage native species.

To improve the view, “culprit” trees were identified that block the view of the bridge. Most of these trees fall in the Viewshed Management Area (outlined in yellow on map below). Two tall maples were identified as particularly blocking the view, both from the trailhead and from the bridge looking toward the lake. A scraggly large black willow on the east side of the creek is also a good candidate for cutting and treatment. Two to three unhealthy red pine near the trail should also be removed to enhance the view. Additionally, several willows are encroaching on the trail and should be removed or trimmed as appropriate. All trees can be cut in any season other than spring, to avoid the spring sap push. Stumps will be treated with 15-25% triclopyr 4 in an oil carrier (diluent oil, diesel, etc) within 2 weeks of cutting. In the canopy gaps, semi-shade tolerant low-growing natives will be planted including pagoda dogwood (*Cornus alternifolia*), beaked hazel (*Corylus cornuta*), and tag alder (*Alnus incana*). The area will then be monitored to determine if other trees would merit removal in future years or if invasive species are encroaching.

At the beginning of the trail is an open area with grasses and small trees, the Floodplain Restoration Area, outlined on the map below. The site is 0.26 acres and is bounded by the trail on the north, concrete water control structure on the south, and the forest edge on the east and west.

Along the edges of this floodplain restoration area, taller conifers and boreal deciduous trees will be planted to mimic historic ravine forests of the region. Within the Tall Vegetation Planting Zone, outlined in blue below, black spruce, white cedar, balsam fir, tamarack, mountain maple, and striped maple will be planted at 6'x6' spacing. These taller species will be kept to the edge to prevent blocking the viewshed as they grow up and will help 'frame' the view of the bridge.
